**Flood Control Project Maintenance  
Levee Inspections**

## Maintenance Issue Types Only, Levee Inspection Report By Mile - Spring 2018

### Levee District No. 0009 (Sutter County)

Waterway	Bank	Unit Miles	Inspection Start/End	Inspector
Unit No. 01 Sutter County, Feather River	Right	6.25	03/13/2018 03/13/2018	Sterling York

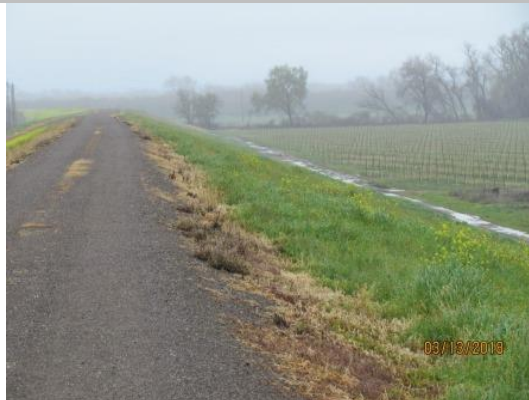
Photo 1 of 3 : SP\_2018\_LD0009\_202\_1\_20180319\_00009.jpg

LM Start	0.00	Rating **	A	Issue No.	1
LM End	6.24	Issue Type +	Ma	Location *	WS
Category	Earthen Levee		GPS Latitude/Longitude		
			Start	End	
Item	Vegetation		39.168814 °	39.255710 °	
			-121.622542 °	-121.636382 °	
DWR ID	DWR_LD0009_01_s_2018_1				
Comment Code					
V1 : Control annual grass and weeds on the levee slopes and easements.					
Inspector Comment					
Annual Vegetation is well maintained, Spring 2018.

View looking upstream waterside of the well maintained annual vegetation at Levee Mile 0.28, Spring 2018.

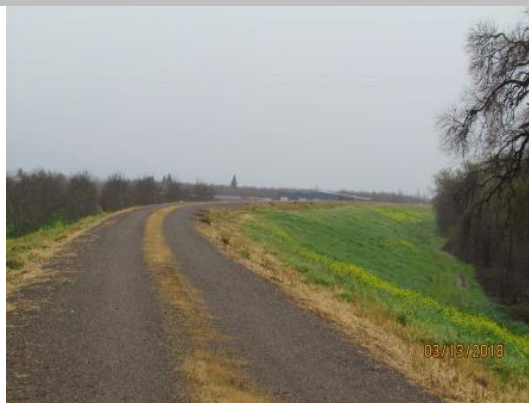
Photo 2 of 3 : SP\_2018\_LD0009\_202\_1\_20180319\_00010.jpg

LM Start	0.00	Rating **	A	Issue No.	1 (cont)	
LM End	6.24	Issue Type +	Ma	Location *	WS	
Category	Earthen Levee			GPS Latitude/Longitude		
				Start		End
Item	Vegetation			39.168814 °		39.255710 °
				-121.622542 °		-121.636382 °
DWR ID	DWR_LD0009_01_s_2018_1					
Comment Code						
V1 : Control annual grass and weeds on the levee slopes and easements.						
Inspector Comment						
Annual Vegetation is well maintained, Spring 2018.

View looking upstream waterside of the well maintained annual vegetation at Levee Mile 2.74, Spring 2018.

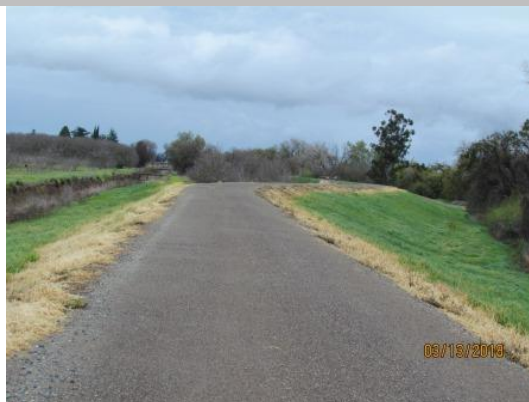
Photo 3 of 3 : SP\_2018\_LD0009\_202\_1\_20180319\_00011.jpg

View looking upstream waterside of the well maintained annual vegetation at Levee Mile 5.96, Spring 2018.

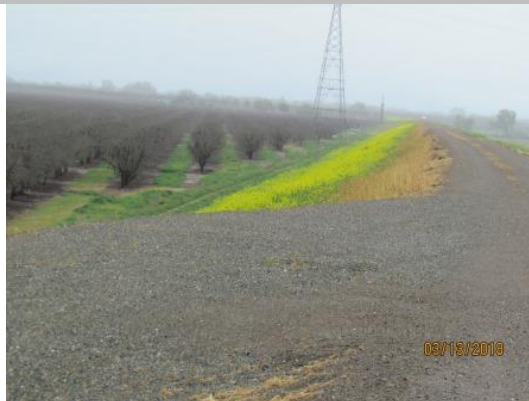
Photo 1 of 3 : SP\_2018\_LD0009\_202\_2\_20180319\_00006.jpg

LM Start	0.00	Rating **	A	Issue No.	2
LM End	6.24	Issue Type +	Ma	Location *	LS
Category	Earthen Levee			GPS Latitude/Longitude	
				Start	End
Item	Vegetation			39.168814 °	39.255710 °
				-121.622542 °	-121.636383 °
DWR ID	DWR_LD0009_01_s_2018_2				
Comment Code					
V1 : Control annual grass and weeds on the levee slopes and easements.					
Inspector Comment					
Annual Vegetation is well maintained, Spring 2018.

View looking upstream landside of the well maintained annual vegetation at Levee Mile 0.56, Spring 2018.

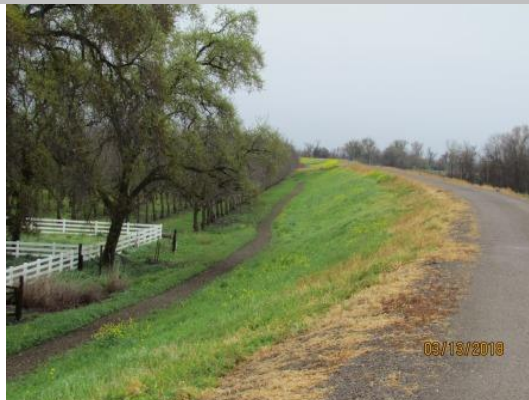
Photo 2 of 3 : SP\_2018\_LD0009\_202\_2\_20180319\_00007.jpg

View looking upstream landside of the well maintained annual vegetation at Levee Mile 3.14, Spring 2018.

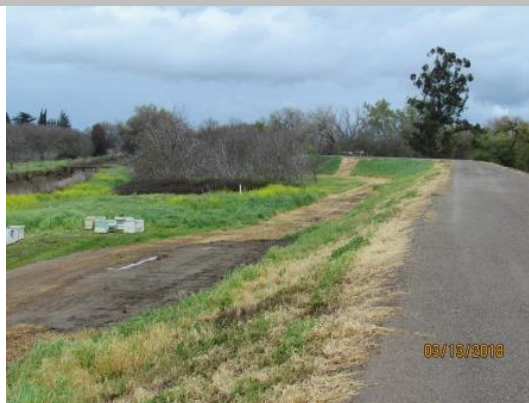
Photo 3 of 3 : SP\_2018\_LD0009\_202\_2\_20180319\_00008.jpg

LM Start	0.00	Rating **	A	Issue No.	2 (cont)	
LM End	6.24	Issue Type +	Ma	Location *	LS	
Category	Earthen Levee			GPS Latitude/Longitude		
				Start		End
Item	Vegetation			39.168814 °		39.255710 °
				-121.622542 °		-121.636383 °
DWR ID	DWR_LD0009_01_s_2018_2					
Comment Code						
V1 : Control annual grass and weeds on the levee slopes and easements.						
Inspector Comment						
Annual Vegetation is well maintained, Spring 2018.

View looking upstream landside of the well maintained annual vegetation at Levee Mile 5.96, Spring 2018.

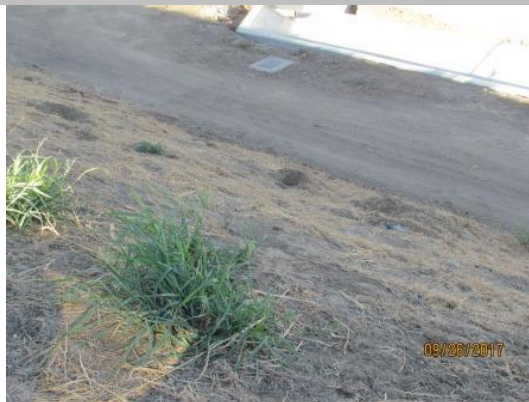
Photo 1 of 1 : SP\_2018\_LD0009\_202\_18\_20180302\_00003.jpg

LM Start	0.09	Rating **	M	Issue No.	18
LM End	0.09	Issue Type +	Ma	Location *	LS
Category	Earthen Levee			GPS Latitude/Longitude	
				Start	End
Item	Animal Control			39.170064 °	39.170064 °
				-121.622563 °	-121.622563 °
DWR ID	DWR_LD0009_01_f_2016_18				
Comment Code					
A3 : No rodents visible, but rodent burrows visible; need to backfill and compact or grout burrows.					
Inspector Comment					
Rodent activity was observed, holes need to be backfilled. Spring 2018.

View on landside of rodent activity and holes, Fall 2017.
